# Case Study: Unbelievable Shelter Remanufacture

### Before Remanufacture: Severely Dilapidated Shelter

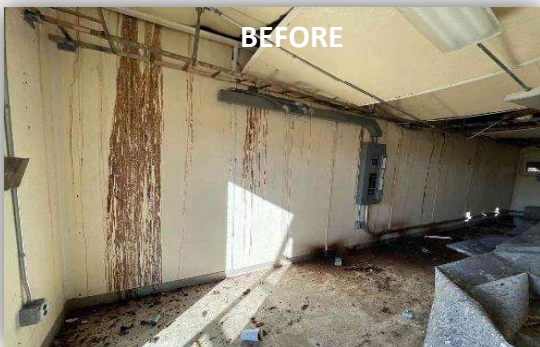
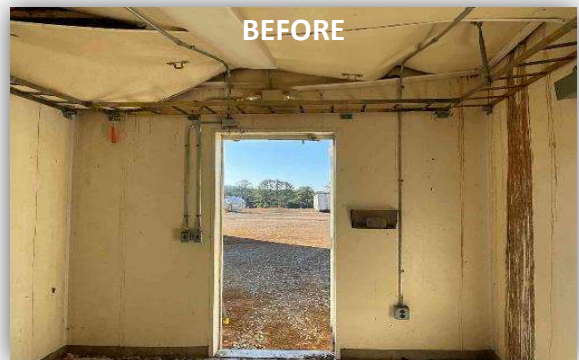
#### Interior Pics Before Remanufacture

The surplus shelter on hand that met the size dimensions required by this service provider was a severely dilapidated 12'x 30' telecom shelter. Part of the interior roof collapsed, and both the interior and exterior had significant cosmetic issues, as shown in the pictures below. While the cosmetic appearance of the shelter appeared disastrous, the shelter's concrete infrastructure was structurally sound.

2. **Interior Upgrades:** Completely restored the interior taking the walls down to bare concrete —then added insulation, fiber re-enforced wall panels, roofing, and SelectTile vinyl flooring that collectively provides a very durable, and energy-efficient environment. This interior also featured the installation of a new door entrance to the telecom section of the shelter.

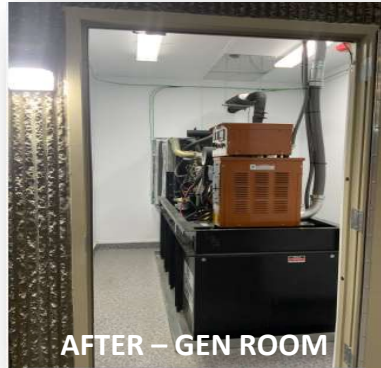
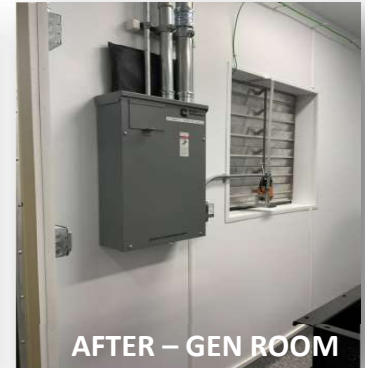
Added entirely new electrical systems, energy-efficient LED lighting, and new 3 ton BARD HVAC systems as well as the generator, battery system, and a Fike Novec fire suppression system housed in the gen room section. CellSite Solutions is also capable of adding any necessary ISP racks and cabling.

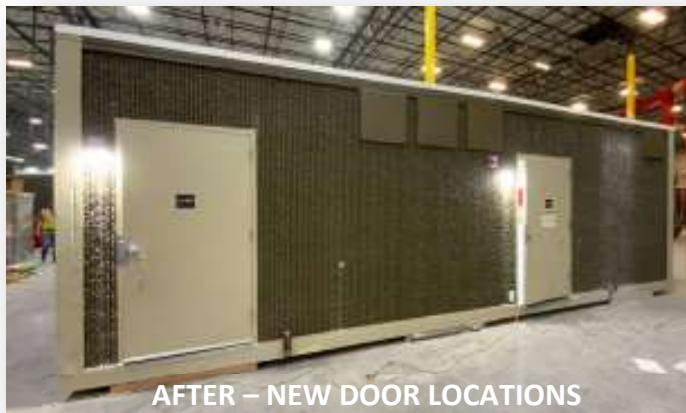
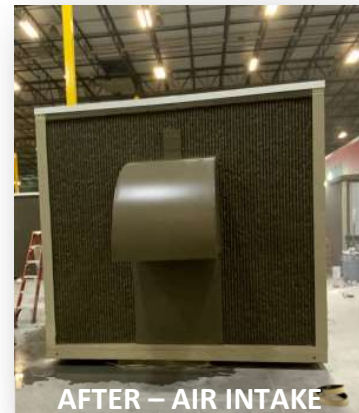
**Exterior Pics After Remanufacture**

4. **Exterior Restoration:** There were several steps to finalize the exterior restoration starting with the addition of a new energy-efficient polyvinyl roof that features a 10-year workmanship warranty, concrete sealant, re-caulked seams, and a fresh coat of industrial-grade paint matching the customer's exterior color specification. From the pics below, you can see the remanufactured shelter features two new door locations on one side, and the side of the shelter that had the original door location is now outfitted with the air intake louver for the gen room.
